Issue Number:	N172404	PDF Date Submitted	01/07/2005

<input checked="" type="checkbox"/> Part - Location:	Ignition Key Cylinder Assembly -Column - Steering				
<input checked="" type="checkbox"/> Complaint:	vehicle can be keyed off with knee while driving				
Issue Type:	Current Prod	Vehicle/Product Line:	3Acar		Region:
<input checked="" type="checkbox"/> Severity:	3	Primary Metric/Score:	LaunchX / 0.025

GMX001 Lock Module Detent in RUN

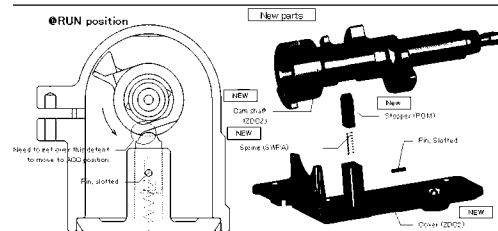
➤ Detent between lock cover and cam shaft:

- ✓ Partial solution based on engineering judgment. No experimental verification that detent is sufficient.
- ✓ If chosen, will drive changes and tuning efforts in ignition switch in order to avoid double detent feel.
- ✓ Design has to become common between Delta, Theta and Kappa
- ✓ Can be combined with the new ignition switch presently sourced for GMT191/2/3 for better detent
